NRL/MR/6180--04-8742

# Performance of Fire Protective Coatings Subjected to DC-ARM Wartime Scenario Fires Aboard Ex-USS *Shadwell*

January 16, 2004

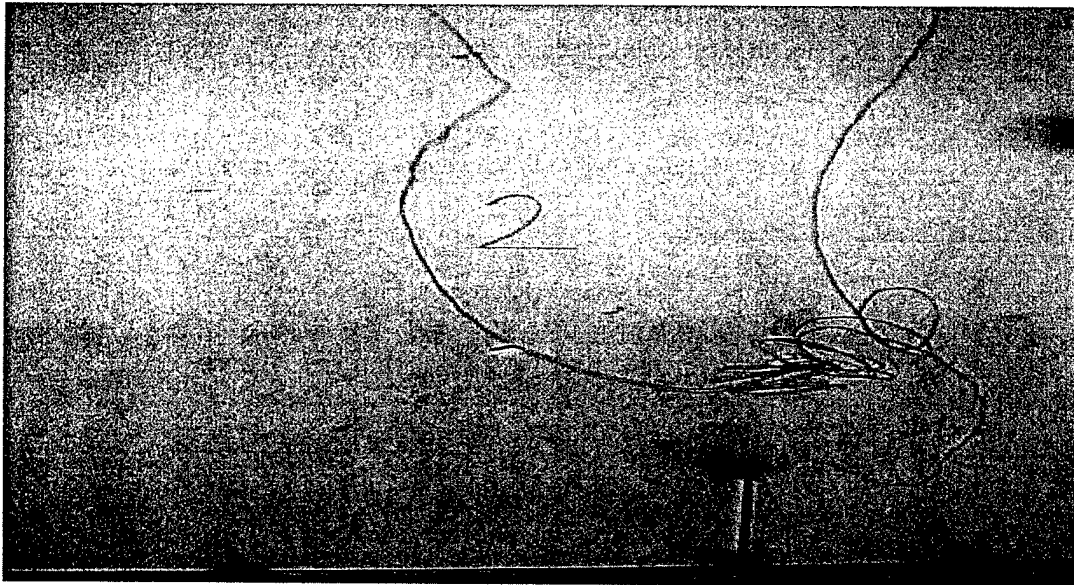
Figures 13-15 are before and after photographs of the coating *Fire Barrier-520*. The test panel was located approximately 4.6 m (15 ft), at roughly 30°, to the port side the ALPHA fire. Figure 14 show the coating produced very little blistering and no cracking. The coating did not intumesce. Considering that the spatial separation between panel 2, panel 1 and the large ALPHA

fire were similar, it seems logical to conclude the *Fire Barrier 520* coating is capable of sustaining higher levels of radiant insult than the fire barrier 1 coating before bubbling.

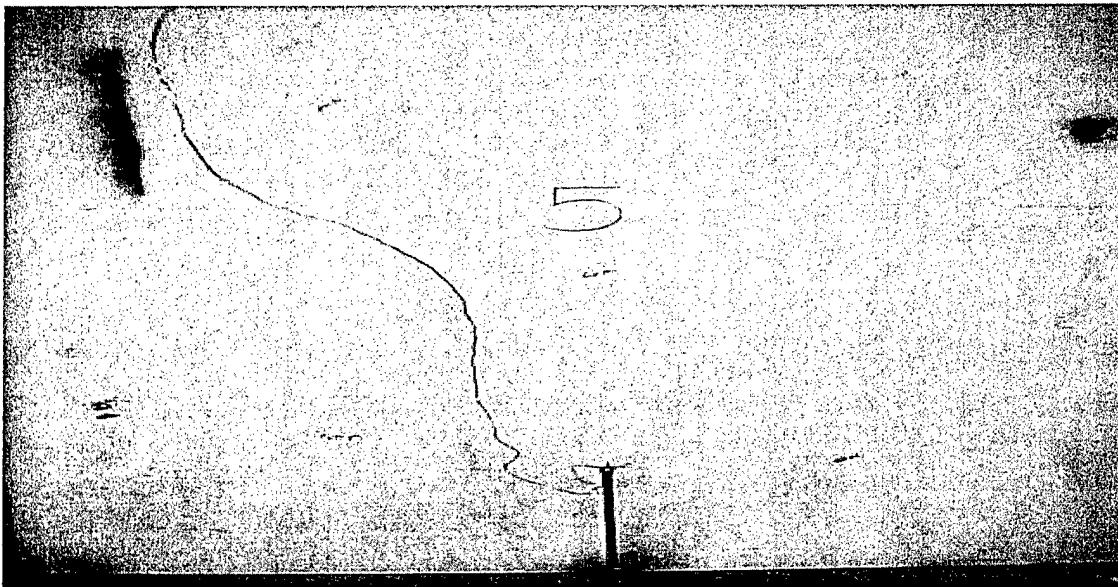
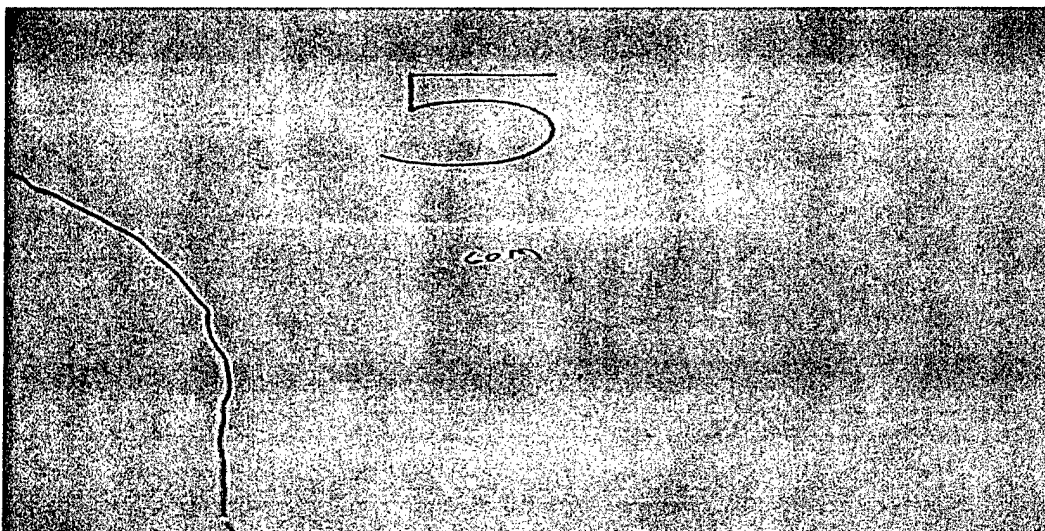
Figures 20-24 are before and after pictures of the coating, *Fire Barrier-2*, applied to the aft side of panel 5. This panel was directly in front of the BRAVO pool fire. The coating would have been subjected to direct impingement of the flame throughout the entire time the heptane pool was burning. A small area of this coating, directly above the fire pan, showed some degree of intumescent response but not of the scope and uniformity that would have been expected. The coating surface was a mixture of hardened crust, blisters and a shallow, intumescent char. The dominant response of the coating on this panel was blistering. There was some post test indication this coating suffered minor cracking during the fire.

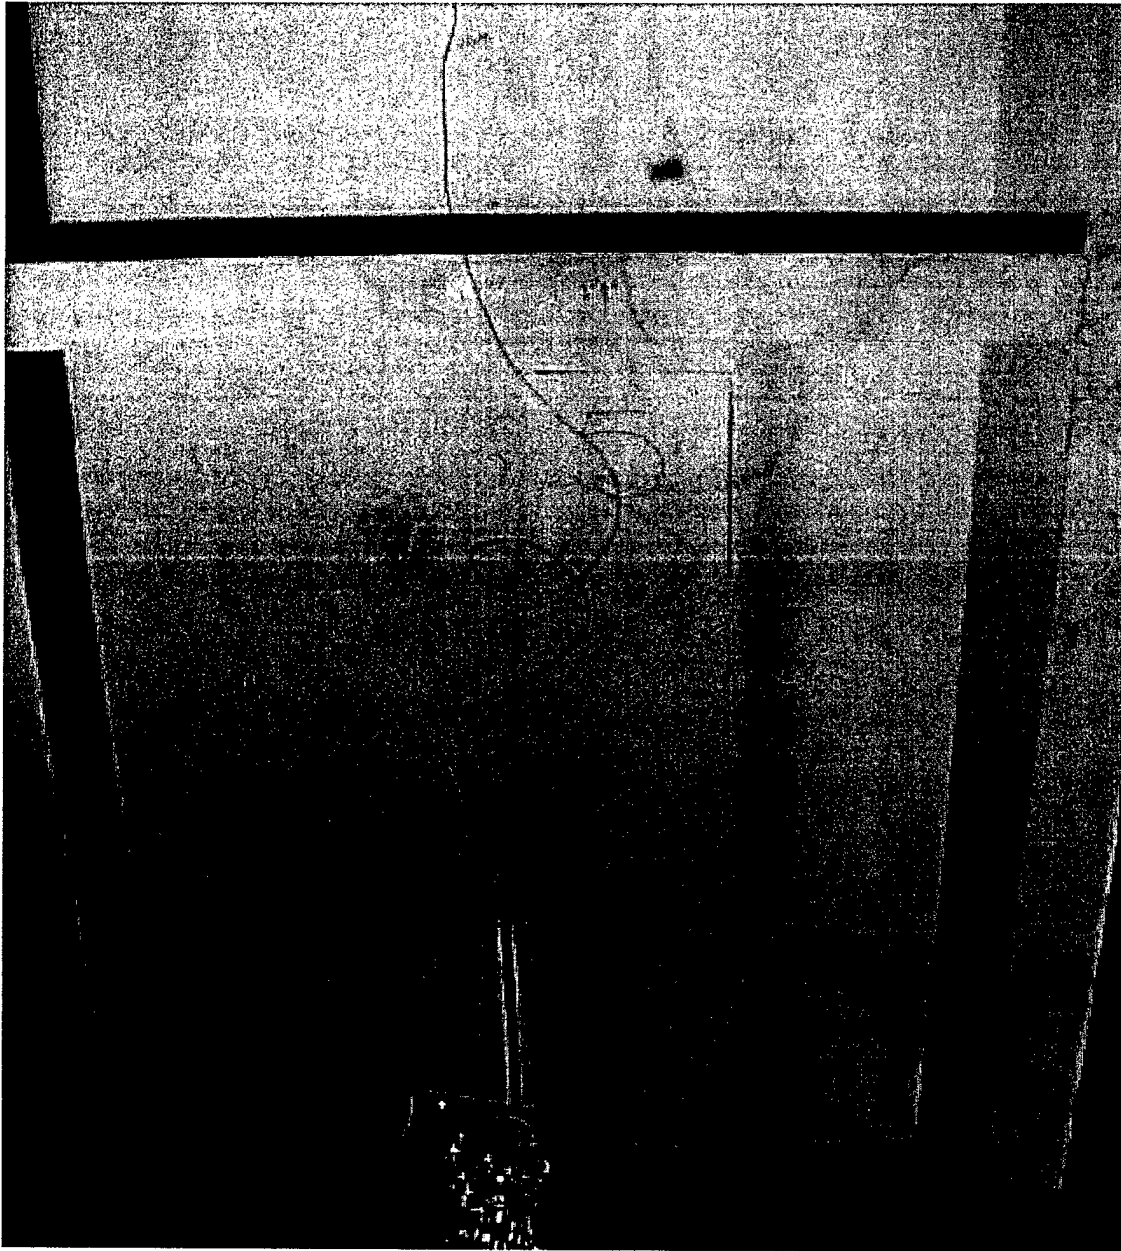
Figure 30 and 31 are before and after pictures of the *Temp Coat* layer applied to the forward surface of this panel. Examination of Figure 31 will reveal a minor discoloration to a small area of this surface. Post-test inspection indicated this discoloration is super imposed atop a weld used to support the aft surface thermocouple. Existence of the weld "short circuited" the *Fire Barrier 520* coating by allowing a direct path for conduction of a heat to the forward side of the panel. With this minor exception, there was no visible impact from the heptane pool to the *Temp Coat* layer.

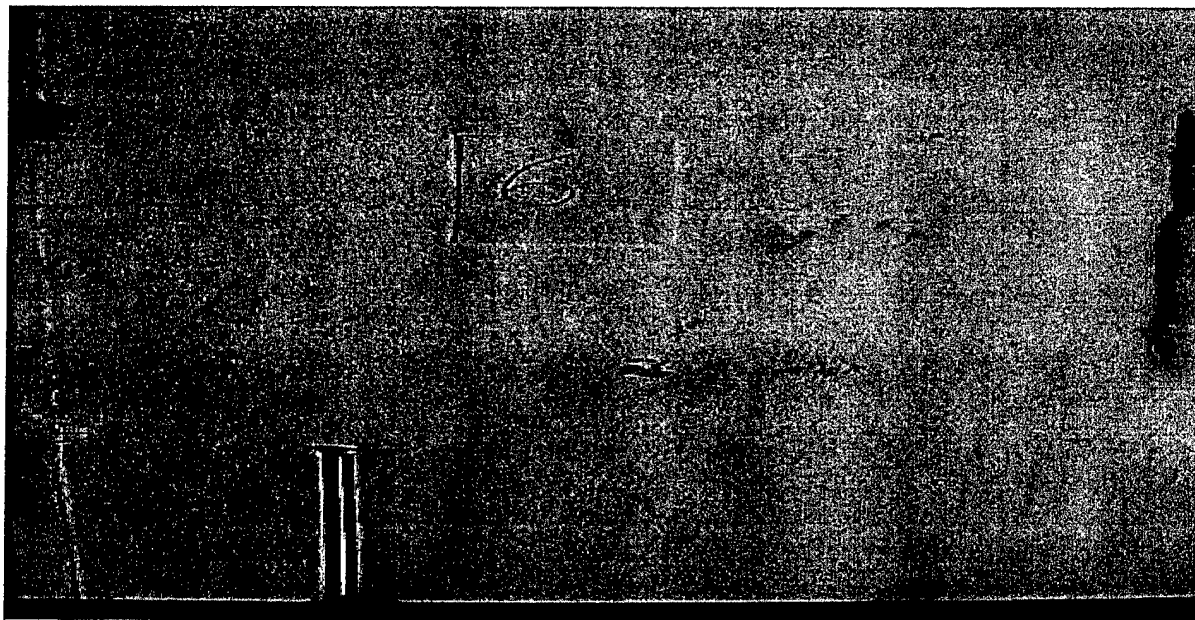
Figures 33-35 are before and after pictures of the coating *Fire Barrier-2*. As seen in the lower left-hand corner of Figure 34, this panel was immediately adjacent to the 5-gallon heptane pool fire. The entire surface of the coating, from deck to overhead, blistered very heavily. There was no indication of any cracking.
